January 4, 2013  
File: 121411939.200.700

**Reference: Boiler Exhaust Gas Dispersion Analysis – Highland Consolidated Middle School, Westville, Nova Scotia**

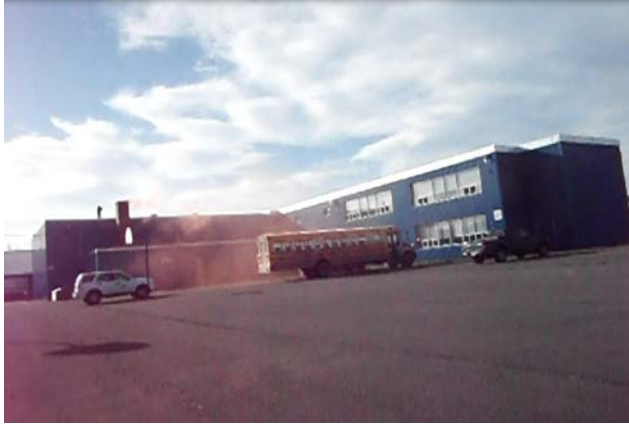
Video cameras were used to monitor the exhaust plume from the boiler stack. Cameras clearly show that as the wind was traveling across the mortar cap of the boiler stack, emissions were being swept directly downwards towards the rear parking lot in a recirculation zone where a tremendous amount of turbulence was observed. Still frame photos were captured at 13:34 and 13:35 during Test Number 3 illustrating this phenomenon located respectively in Photos 1 and 2 below.

**Photo 1: Showing smoke emitter deployed in Test No. 3 at 13:34 minute mark. Direct reading instrument at Location 3 on lower mechanical room roof measured CO concentration of 0.2 ppm during the same time this still frame was captured.**

The visualization portion of the investigation showed that the boiler exhaust plume was not streamlining over top of the HCMS in an efficient manner. Videos and still images show that the plume was washing downwards in a recirculation zone at ground level where a large amount of turbulence was observed. The exhaust plume could be seen circulating at the rear entrance of the HCMS and also washing against the southeast facing classrooms before sweeping around the northern end of the school away from the property.

Although no significant concentrations of boiler combustion contaminants were measured on the day of the investigation, visually it was determined that the dispersion patterns of the boiler exhaust was interacting with the building structure and down-washing to ground level to an area frequented by building occupants. As a due diligence measure, the boiler stack should be fitted with an extension piece to raise the height of the stack allowing the exhaust emission to enter a streamline zone over the school preventing recirculation.

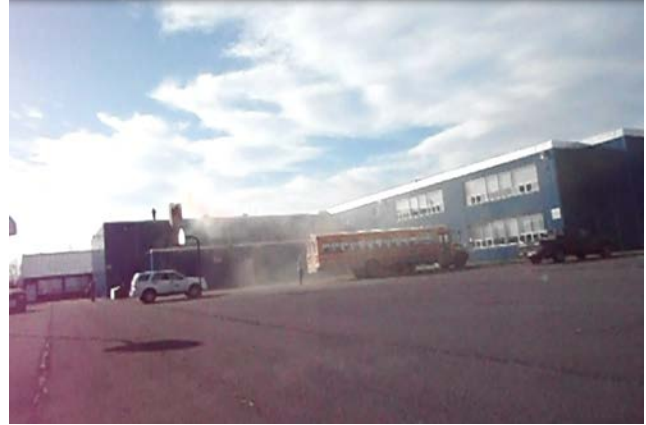
**Photo 2: Showing smoke emitter deployed in Test No. 3 at 13:35 minute mark. Direct reading instrument at Location 3 on lower mechanical room roof measured CO concentration of 0.1 ppm during the same time this still frame was captured.**
